NBSIR 74-390

ELECTROMAGNETIC NOISE IN ITMANN MINE

Electromagnetics Division
Institute for Basic Standards
National Bureau of Standards
Boulder, Colorado 80302

June 1974

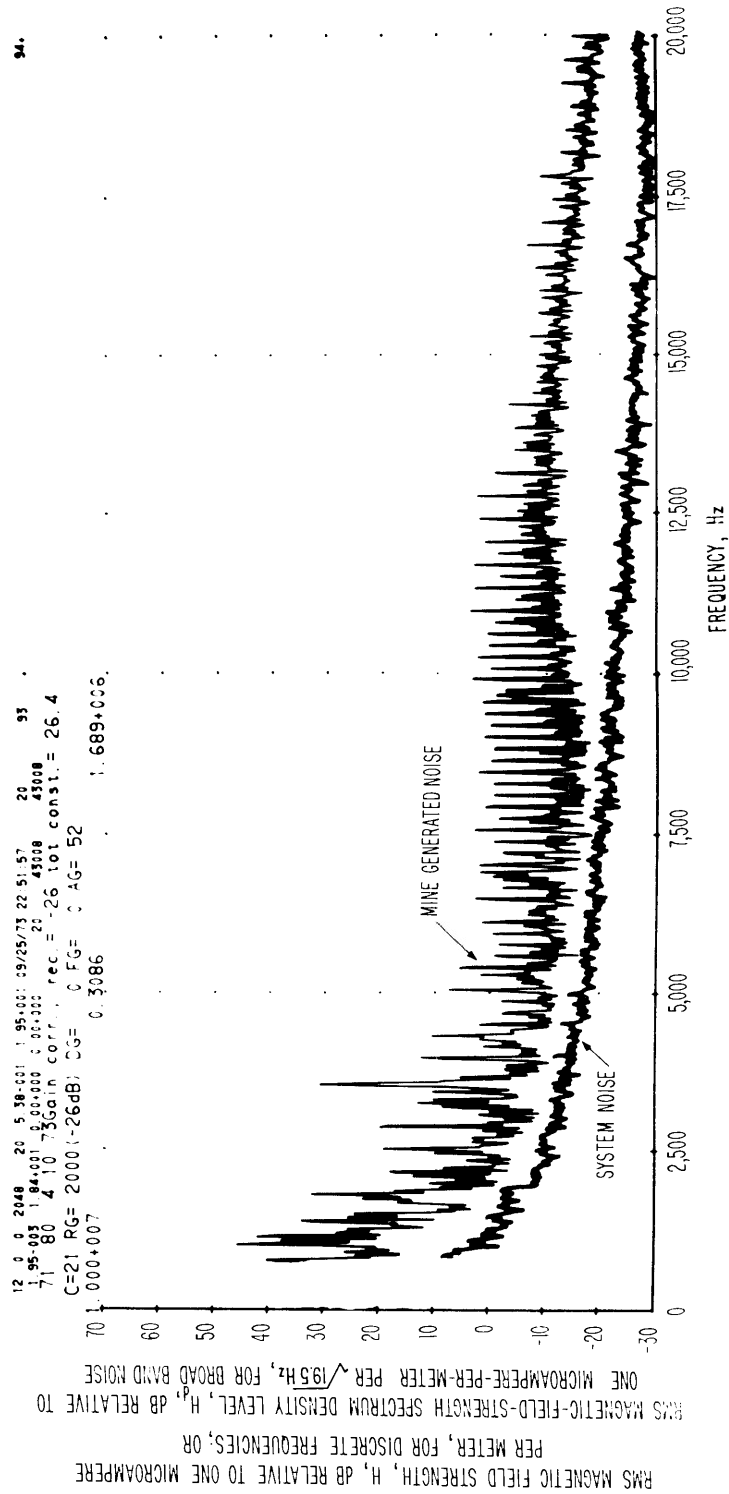
Figure 3-15 Vertical component of magnetic field spectrum about 3 meters from long wall machine, Farley panel, Itmann No. 3 Mine, 2:30 p.m., April 17, 1973. Calibration is valid from 750 Hz to 20 kHz.

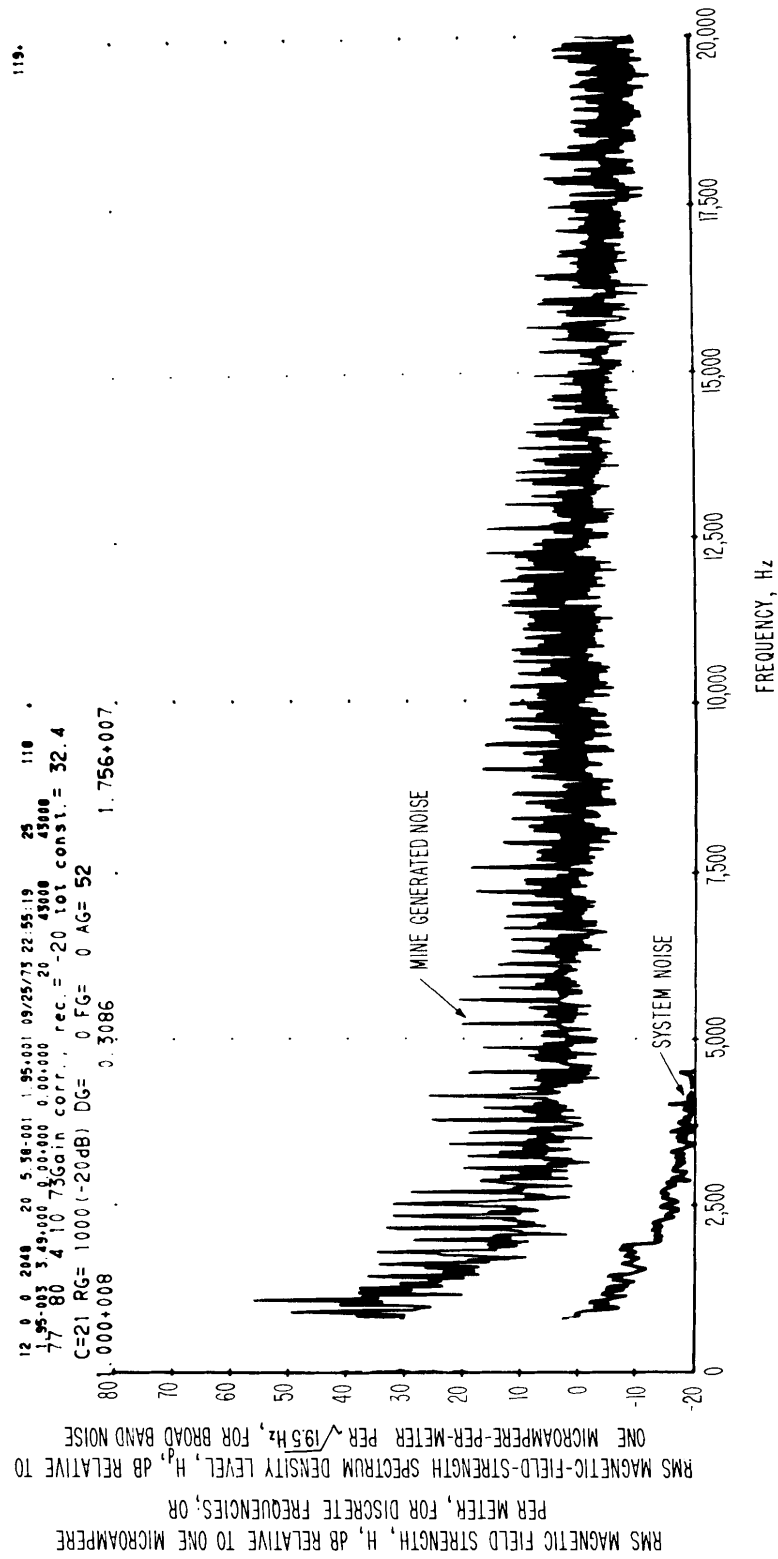
Figure 3-19 Vertical component of magnetic field spectrum at end of haulageway
 in Farley panel, Itmann No. 3 Mine, 12:25 p.m., April 17, 1973.
 Calibration is valid from 750 Hz to 20 kHz.

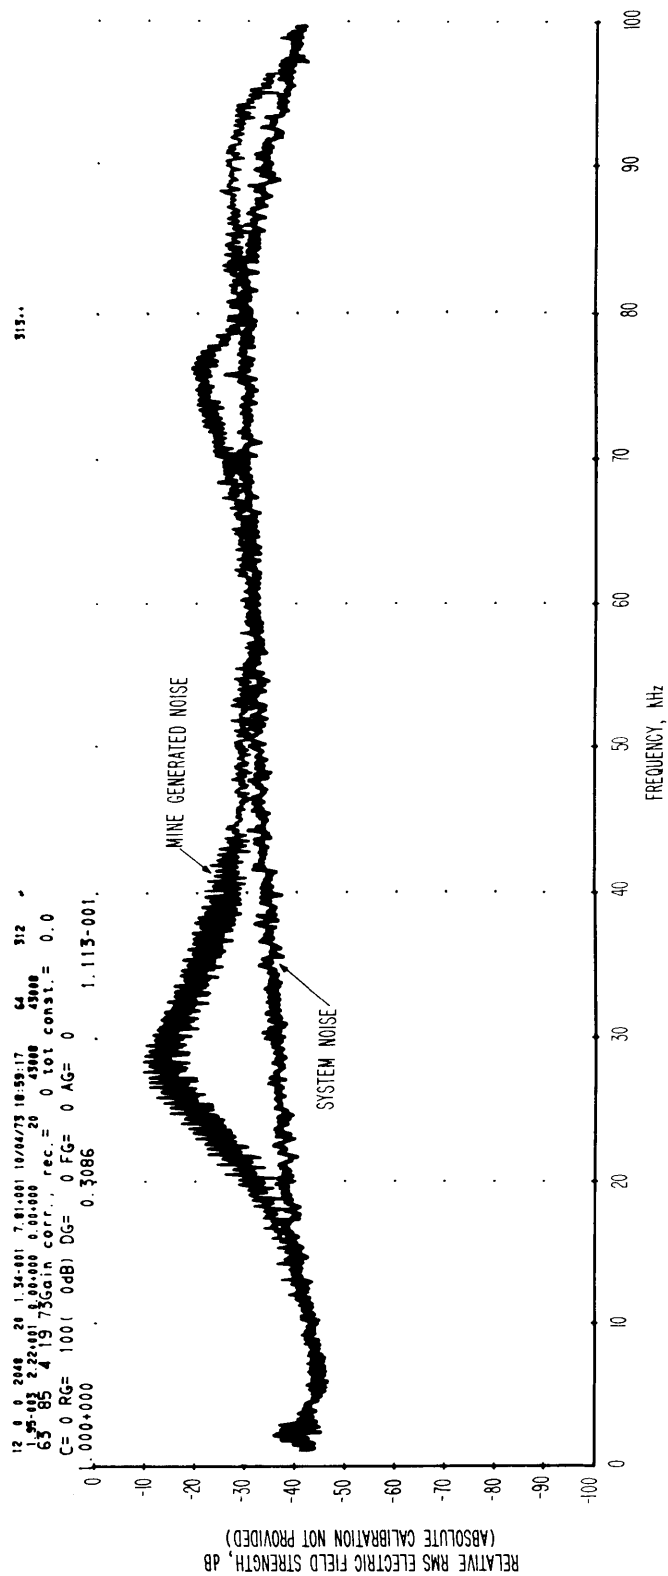
Figure 3-22 Spectrum of electric field strength obtained with an active dipole 1 kHz to 100 kHz, Itmann Mine, underground, Farley panel, dipole ends parallel with drift, 0.75 meters from phone line, conveyor belt starting up, 12:42 p.m., April 19, 1973. Spectral resolution is 78.1 Hz.

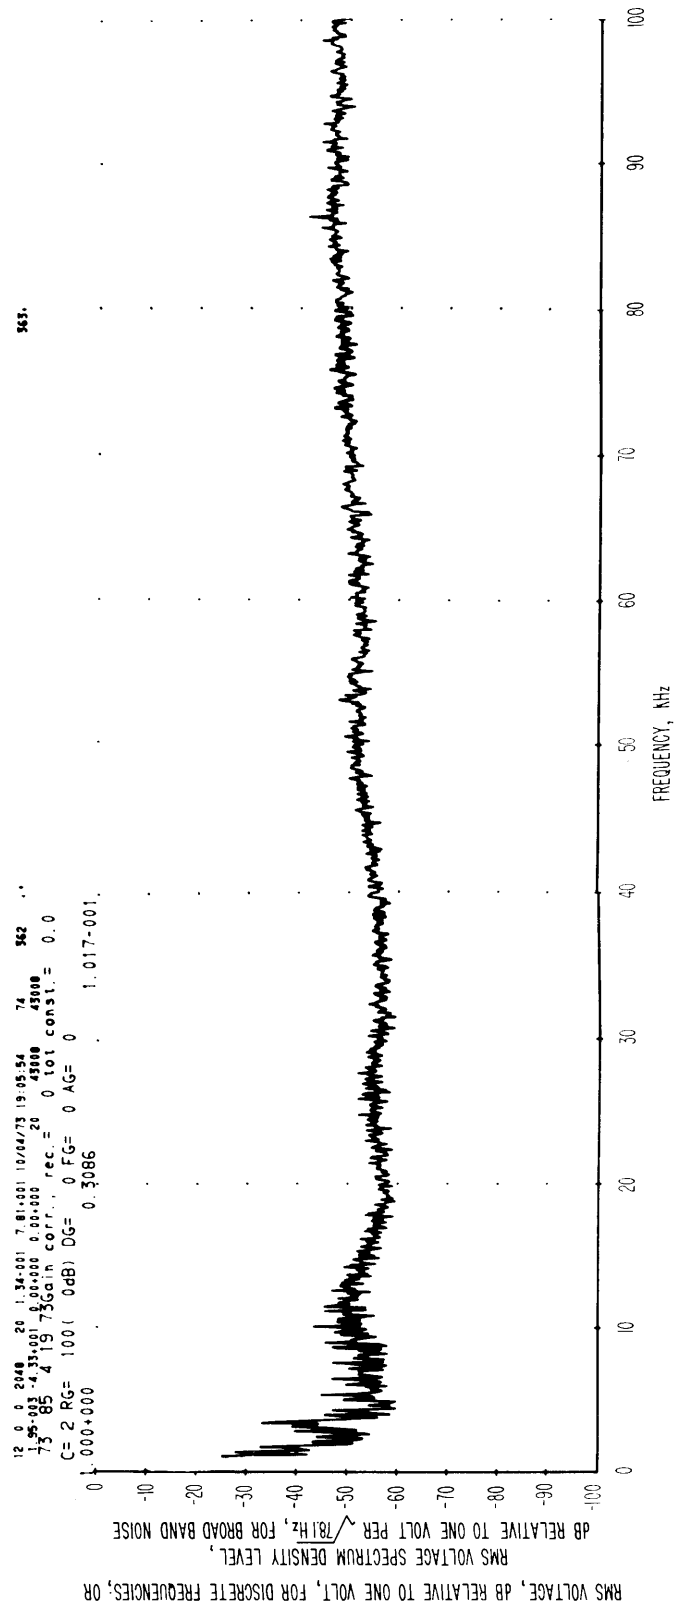
Figure 3-23 Voltage spectrum obtained from roof bolts located 15.2 meters apart, 1 kHz to 100 kHz, Itmann Mine, Farley panel, 1:45 p.m., April 19, 1973. Spectral resolution is 78.1 Hz.

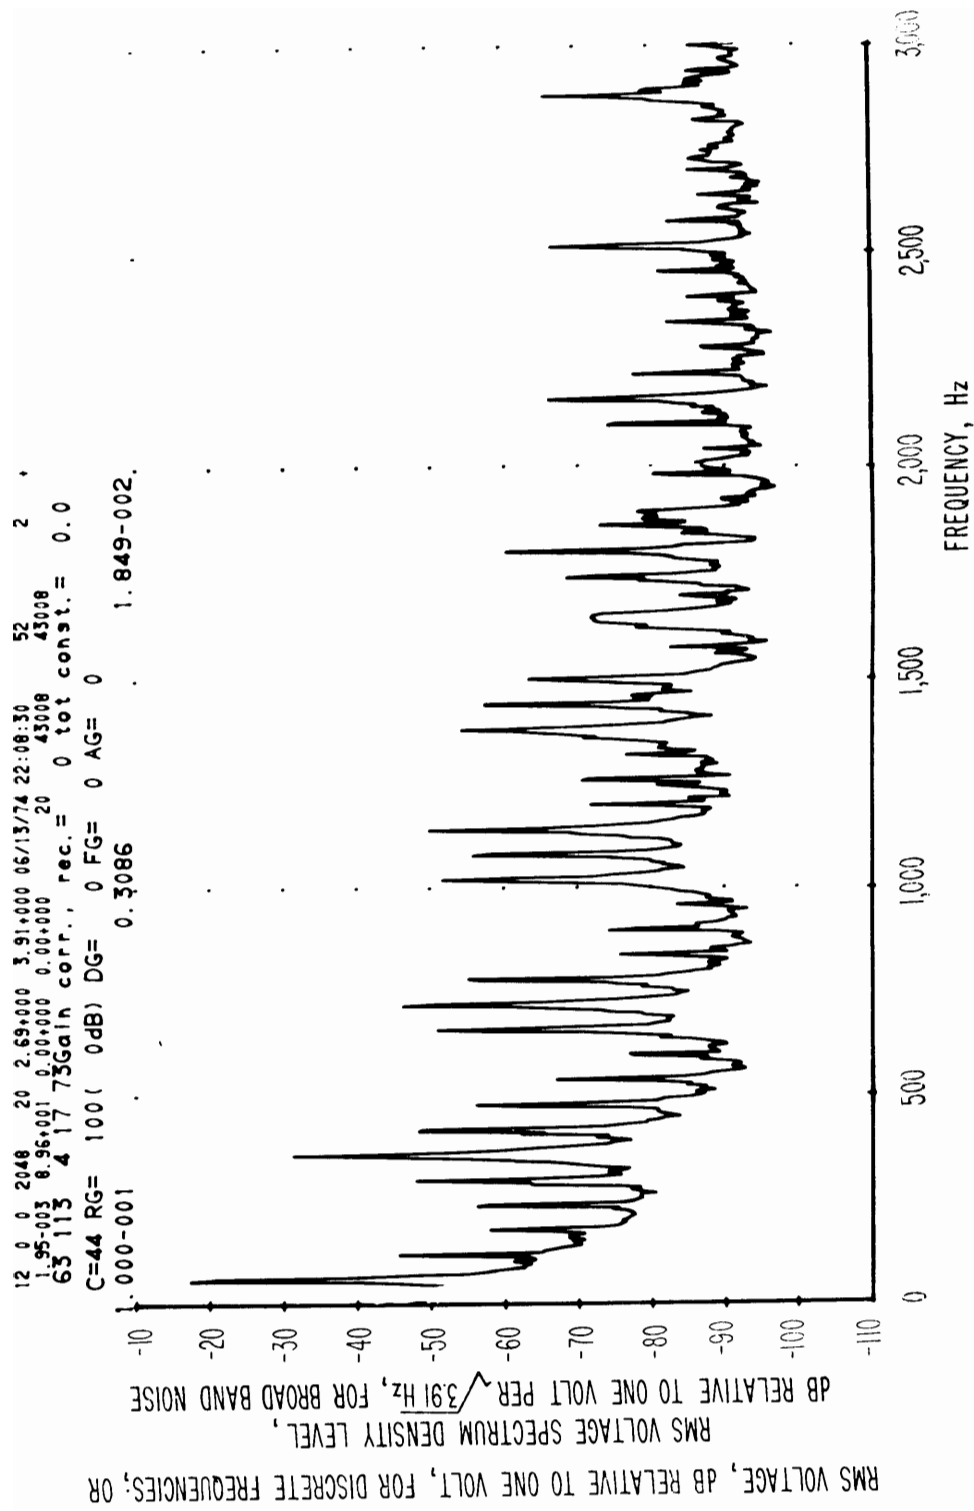
Figure 3-24 Voltage spectrum obtained from roof bolts located 15.2 meters apart, 40 Hz to 3 kHz, Itmann Mine, Farley panel, 1:45 p.m., April 19, 1973. Spectral resolution is 3.91 Hz.

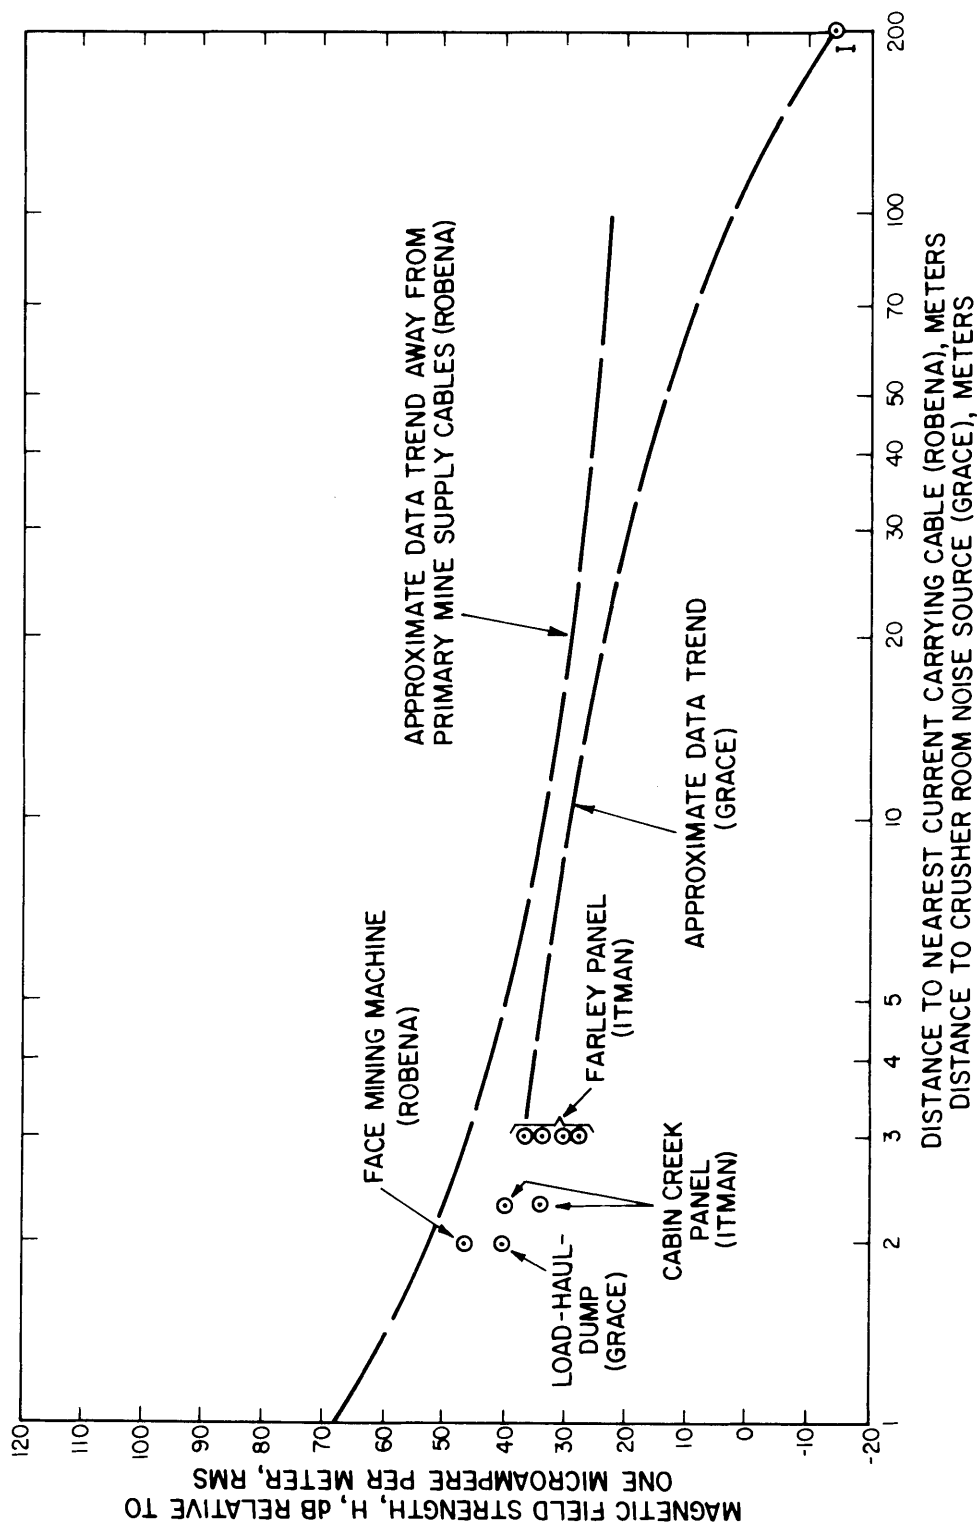
Figure 3-26 Comparison of the logarithmic average of magnetic field strengths at six frequencies between 1 kHz and 3 kHz of Itmann, Grace, and Robena Mines as a function of distance from noise source.

Figure 3-26 is a summary of magnetic field strength at powerline harmonic frequencies observed within Itmann (ac-powered longwall), Robena (all 600 v dc) and the Grace (diesel-powered haulage) mines. Plotted are the dB averages of six powerline harmonics. This logarithmic average masks the highest single value. Average fields at five locations in Itmann are plotted as a function of distance from the nearest current-carrying cable or wire. The six frequencies chosen are between 1020 Hz and 2940 Hz and are either the third through eighth harmonic of 360 Hz, or the highest adjacent powerline harmonic.

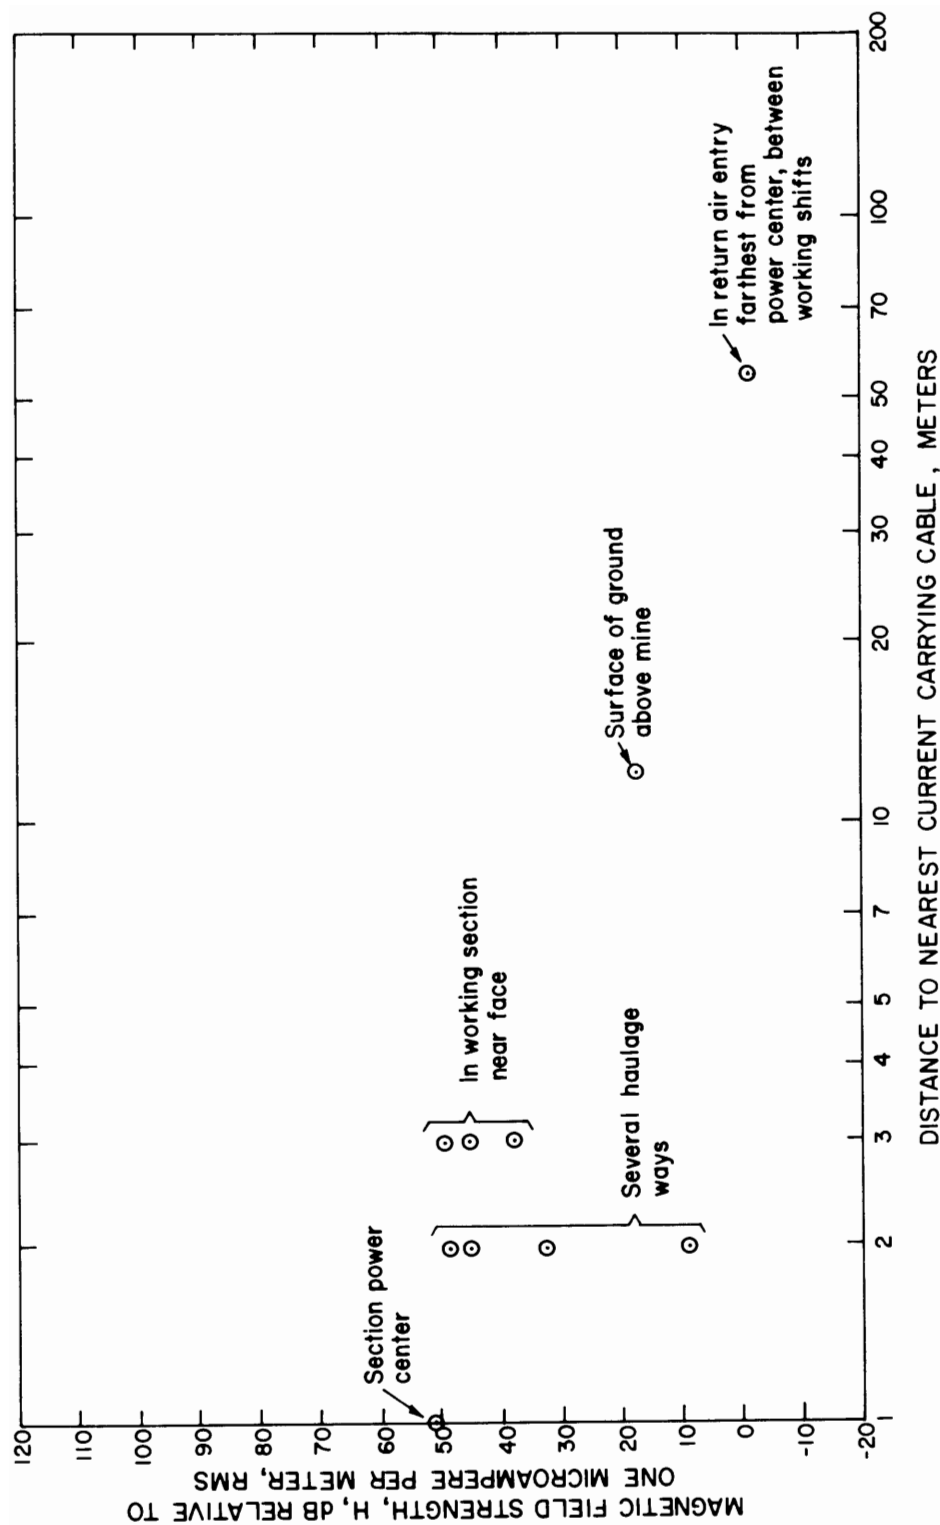
Figure 3-27 Logarithmic average magnetic field strength in McElroy Coal Mine in the frequency range 1080 Hz to 2880 Hz, produced usually by power line harmonics 3 through 8 of 360 Hz. Antenna sensitive axis orientation is vertical (up-down).

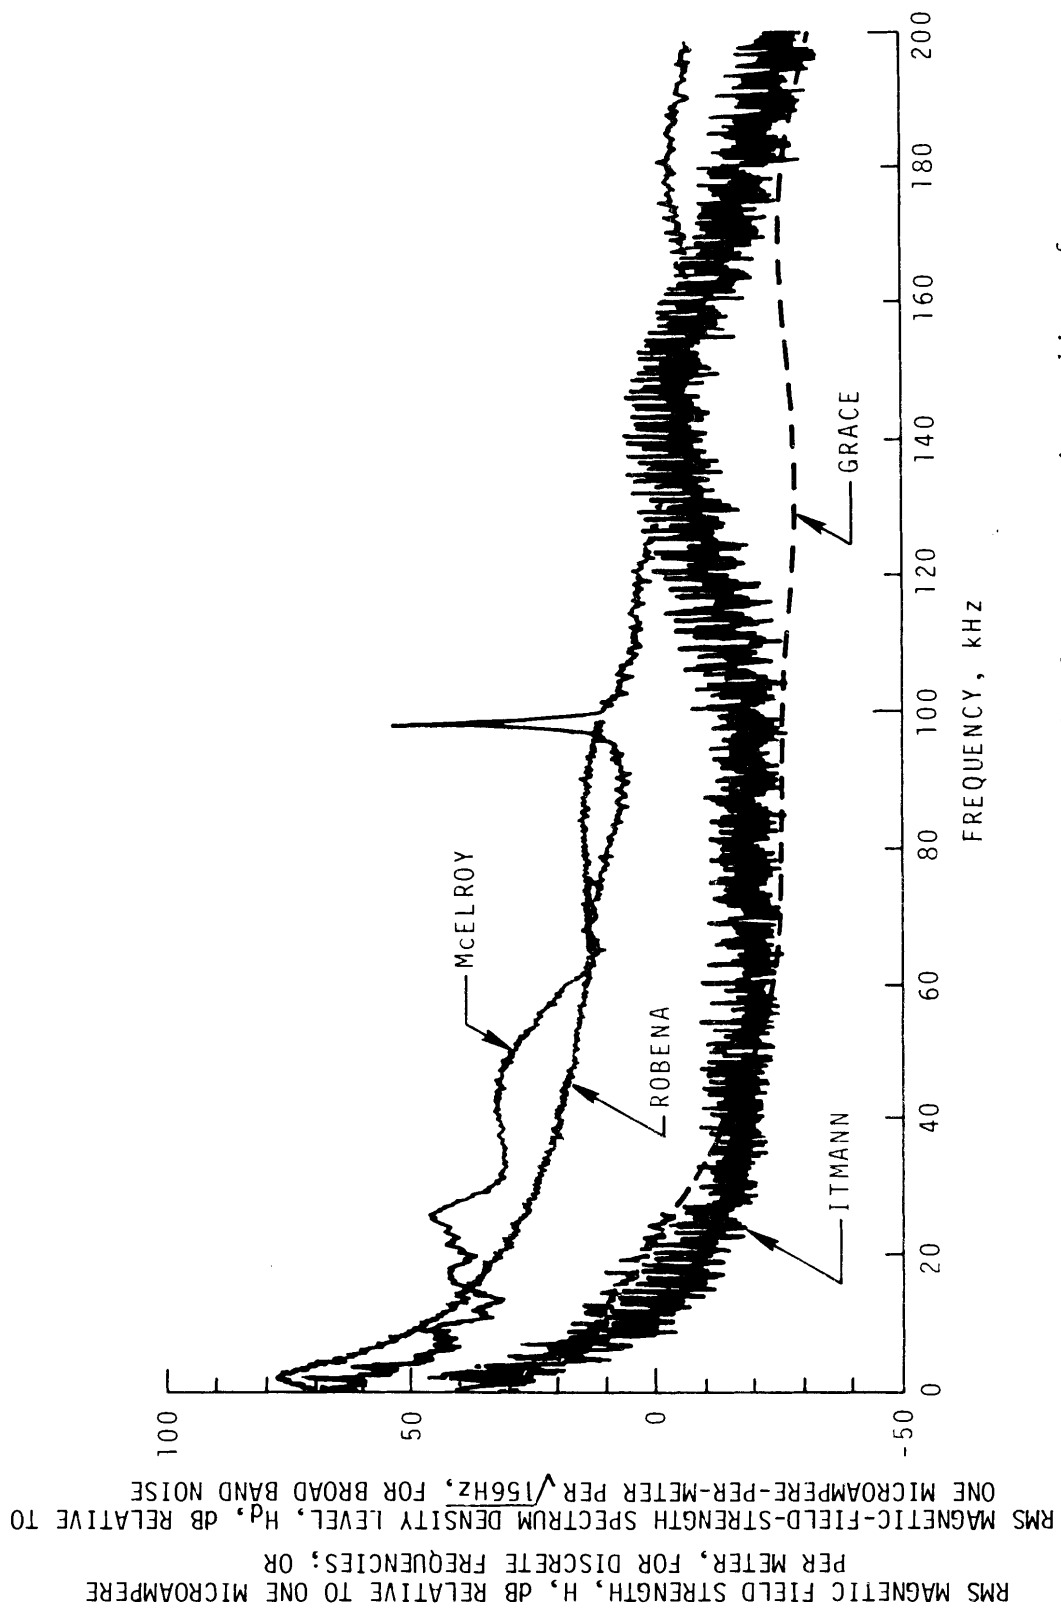
Figure 3-28 Comparison of E-M noise levels near operating machinery from four mines. Vertical magnetic-field components are shown. Broken sections of the curves represent system noise.

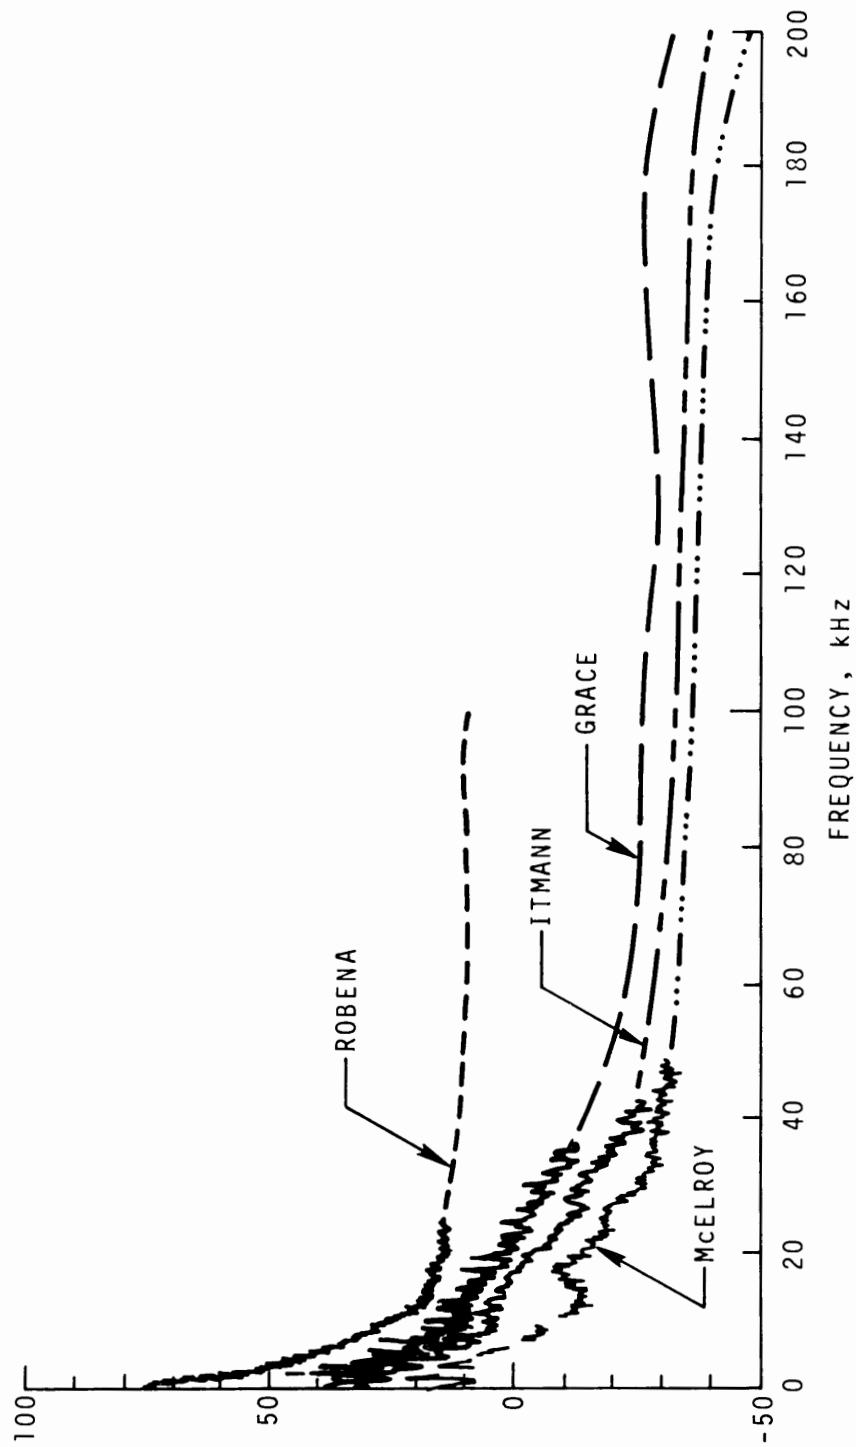
Figure 3-29 Comparison of E-M noise levels along haulageways in four mines. Vertical magnetic-field components are shown. Broken sections of the curves represent measurement-system noise levels.

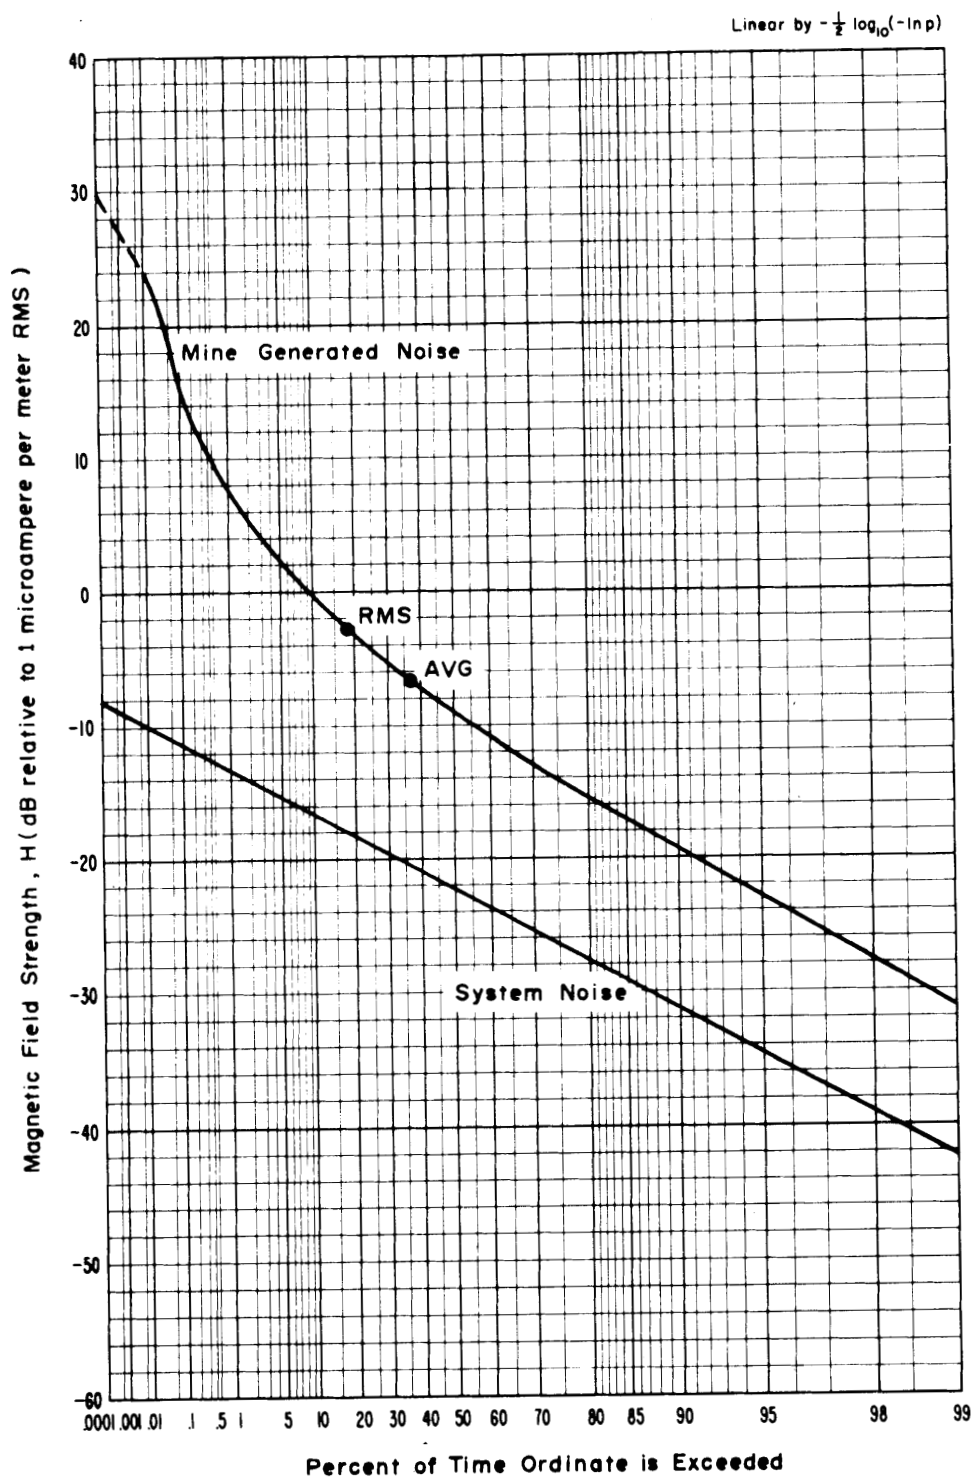
Figure 4-1 APD, 10 kHz, vertical component, 1.0 kHz predetection bandwidth, April 17, 1973, 11:40 a.m., Cabin Creek, Itmann #3.

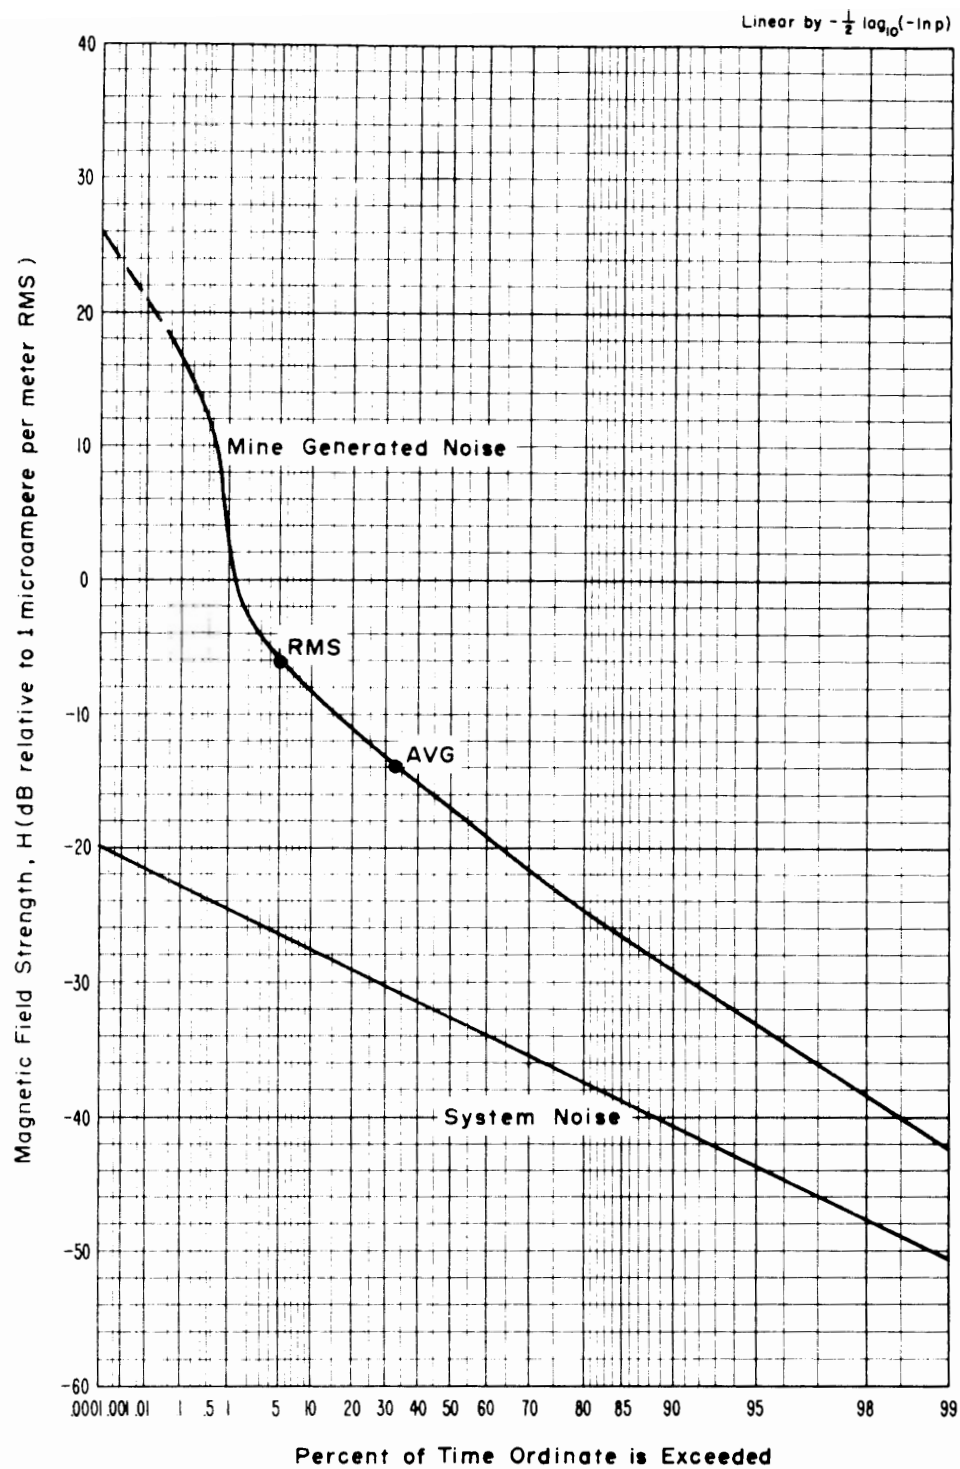
Figure 4-2 APD, 30 kHz, vertical component, 1.0 kHz predetection bandwidth, April 17, 1973, 12:20 p.m., Cabin Creek, Itmann #3.

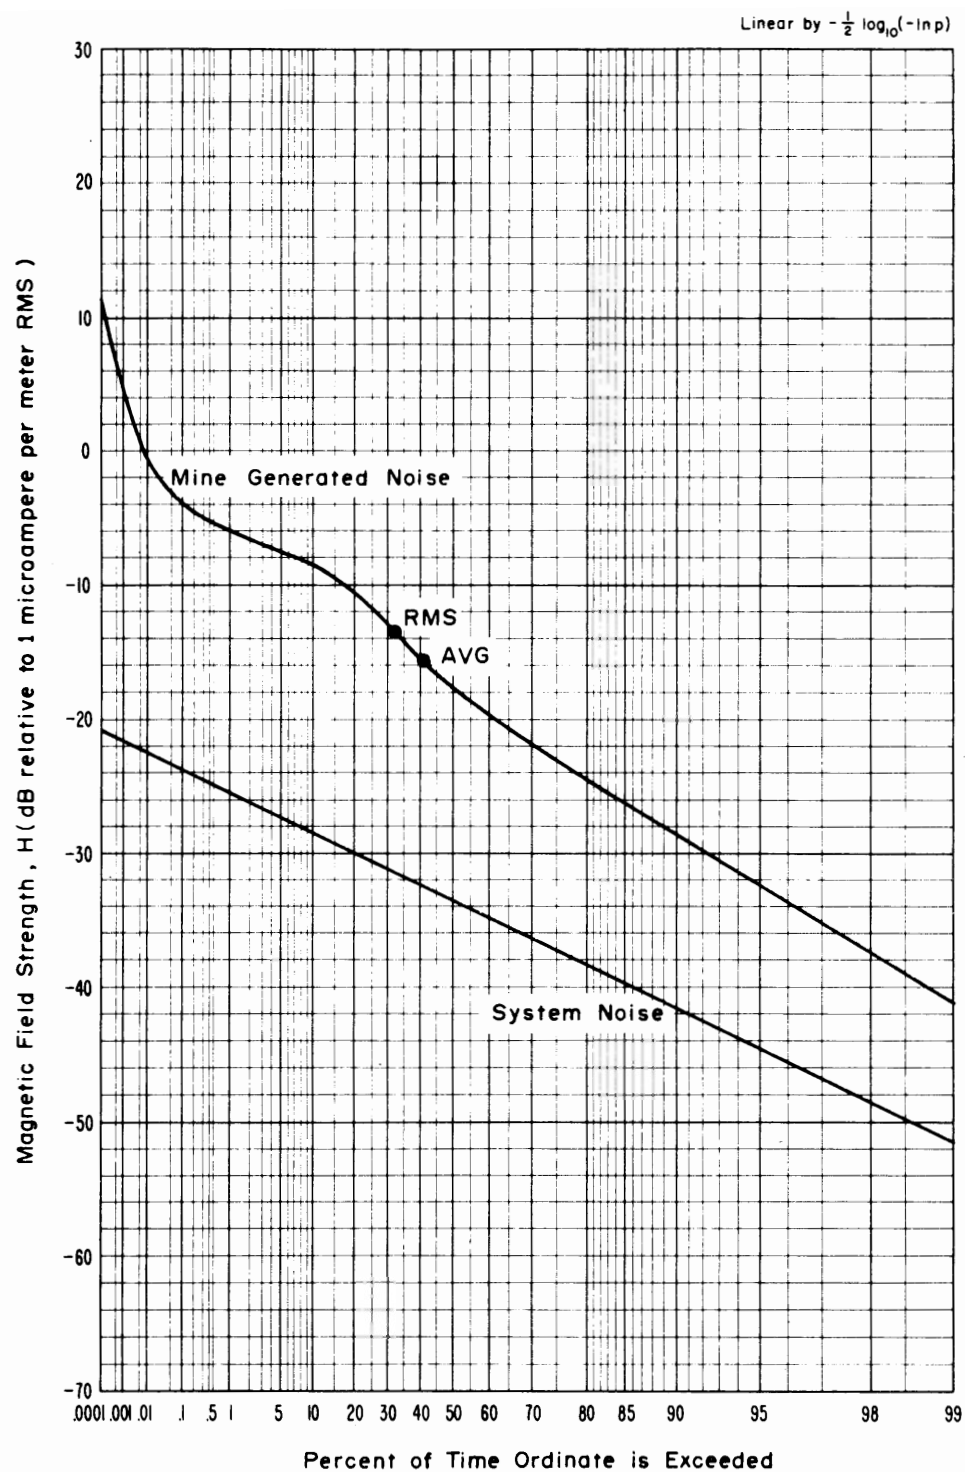
Figure 4-3 APD, 70 kHz, vertical component, 1.0 kHz predetection bandwidth, April 17, 1973, 12:50 p.m., Cabin Creek, Itmann #3.

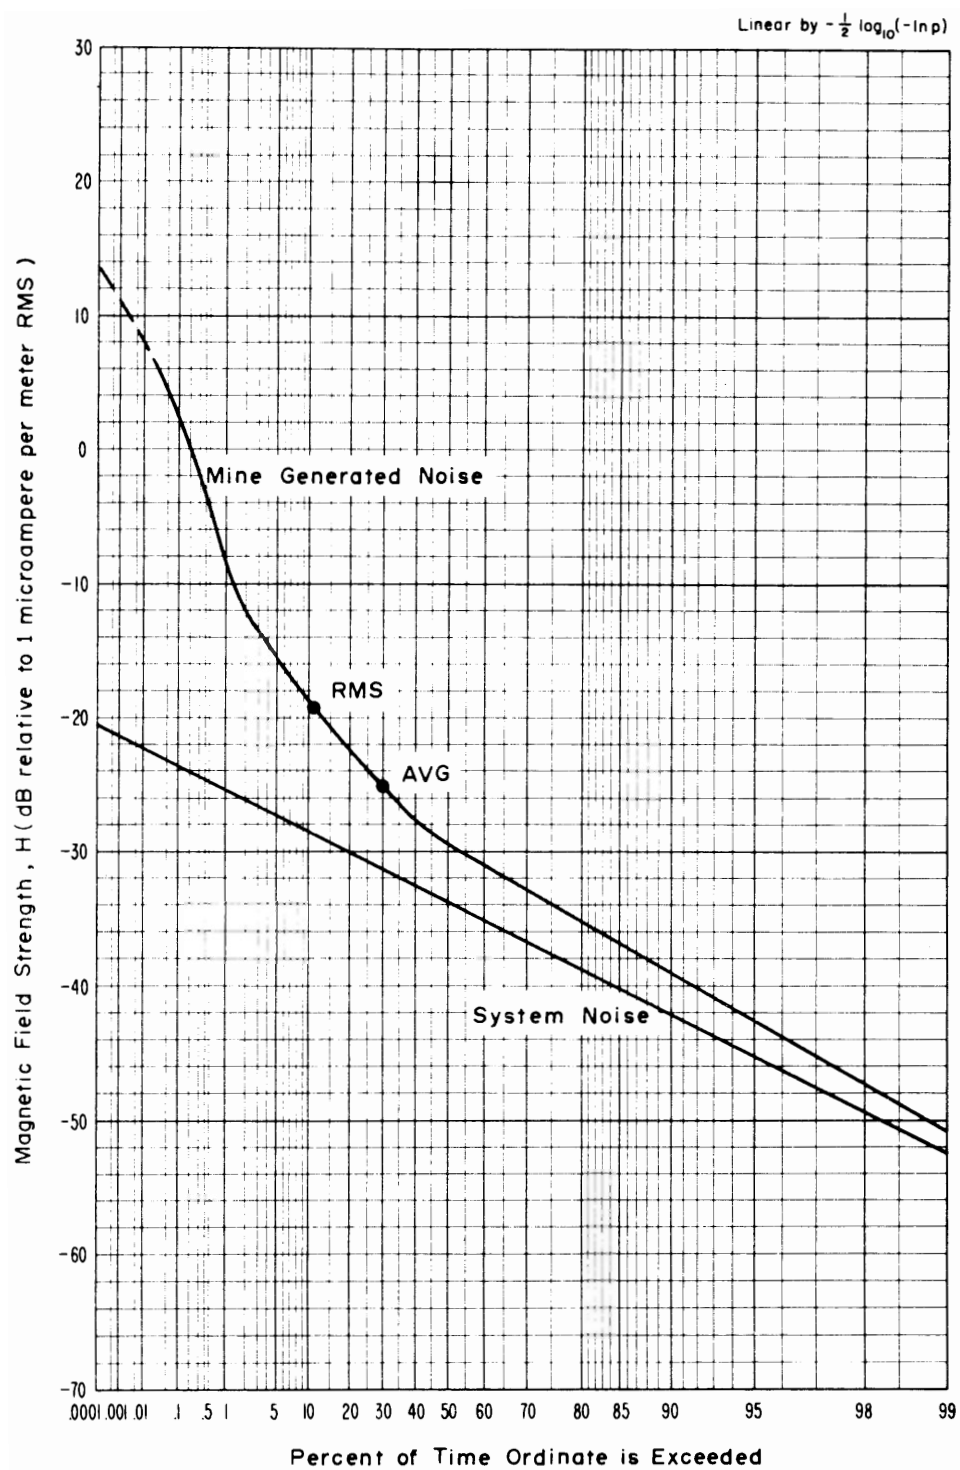
Figure 4-4 APD, 130 kHz, vertical component, 1.0 kHz predetection bandwidth, April 17, 1973, 1:30 p.m., Cabin Creek, Itmann #3.

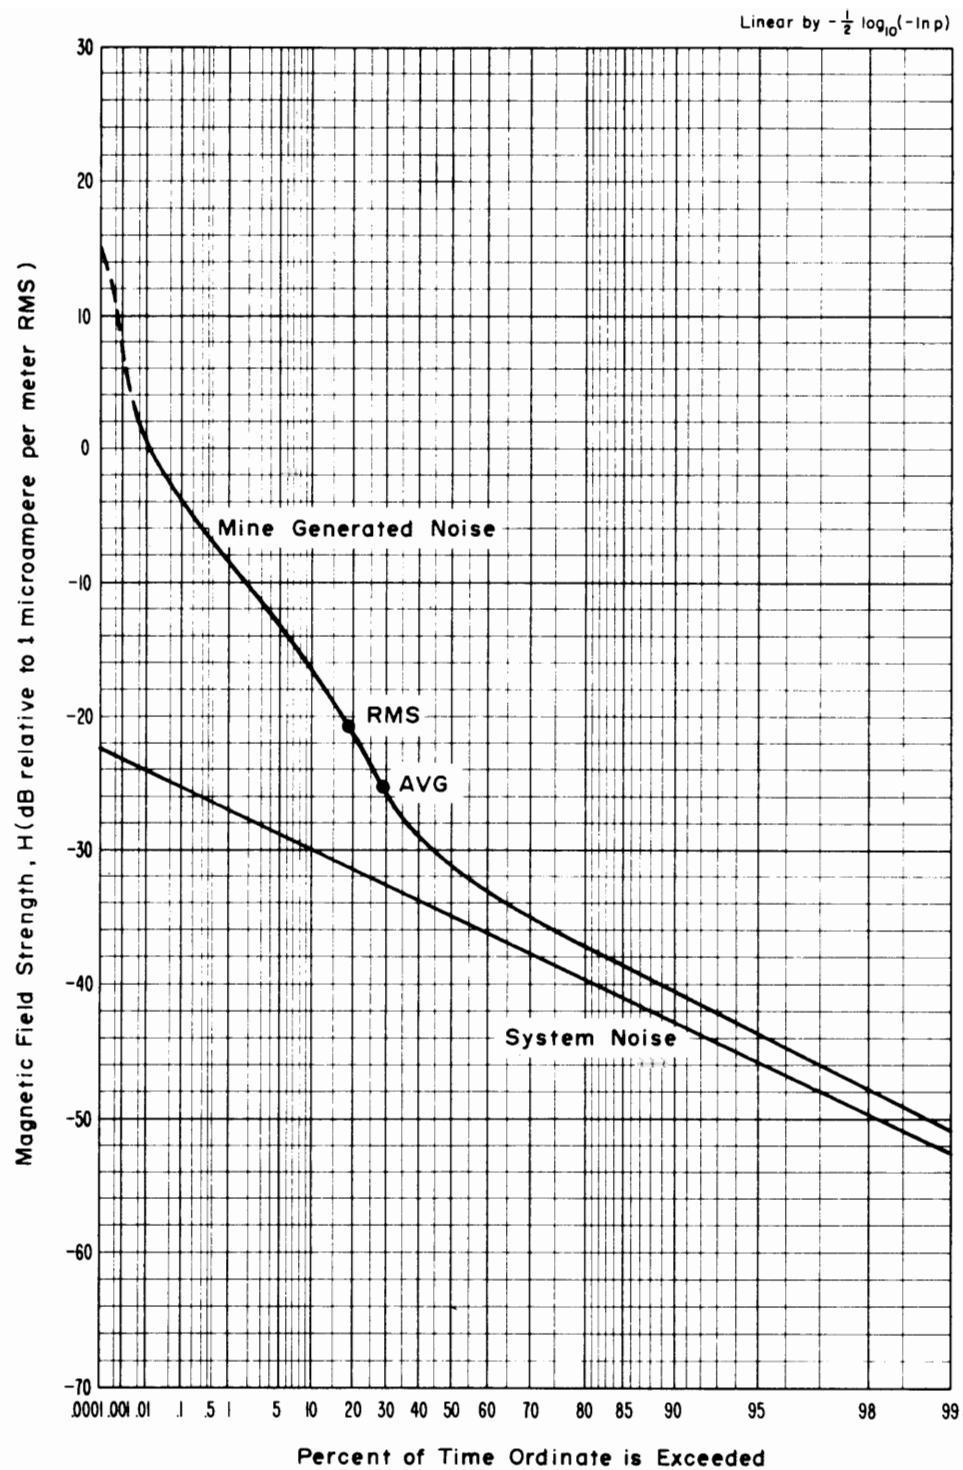
Figure 4-5 APD, 160 kHz, vertical component, 1.0 kHz predetection bandwidth, April 17, 1973, 2:20 p.m., Cabin Creek, Itmann #3.

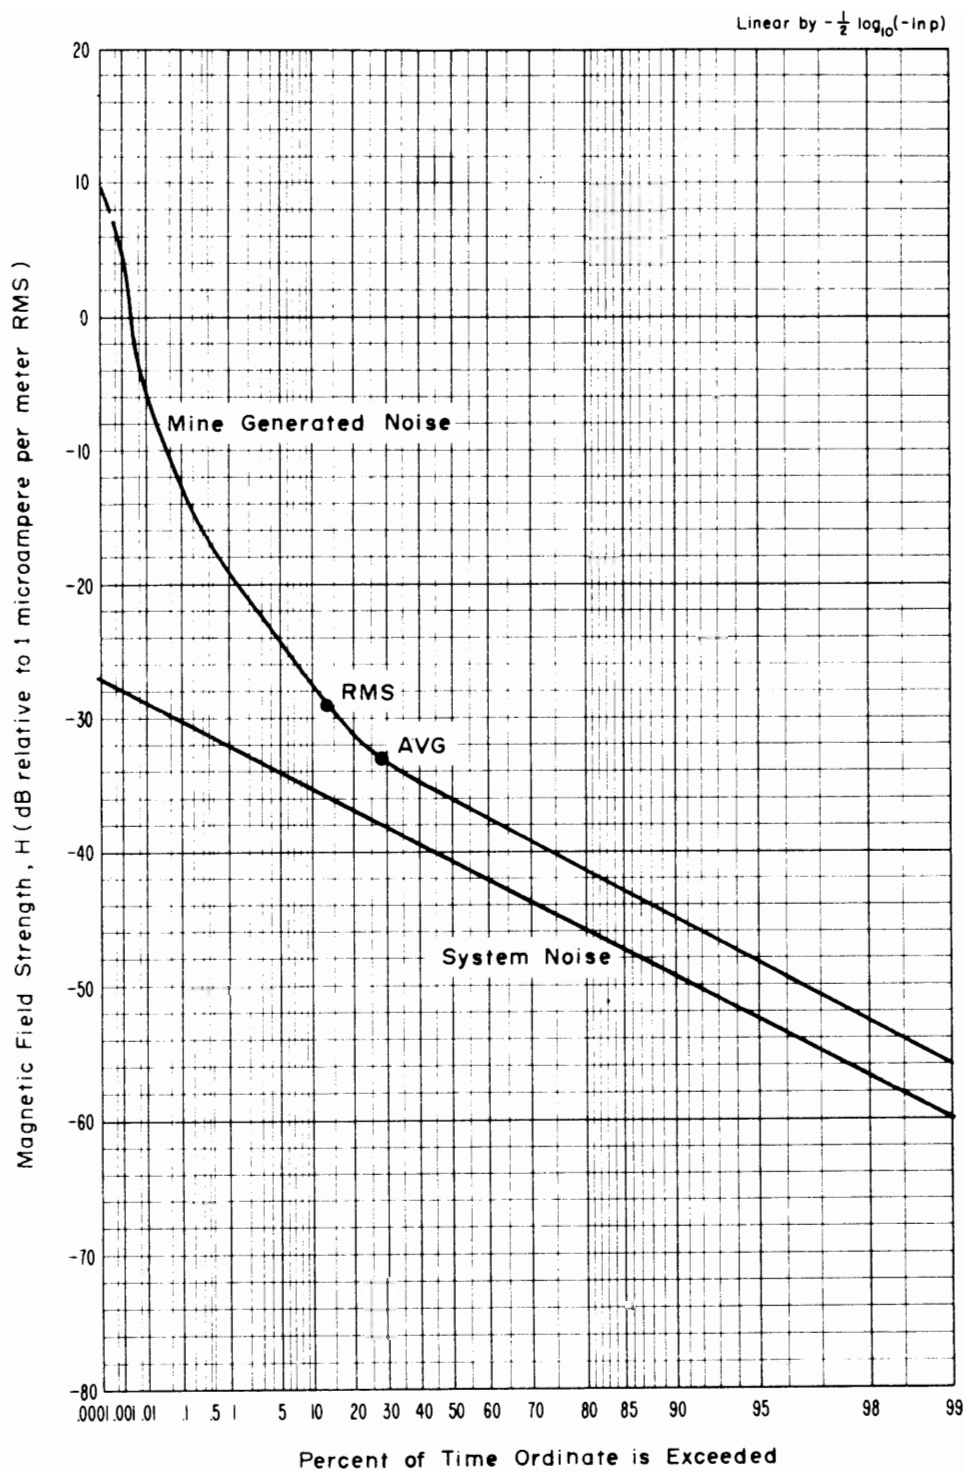
Figure 4-6 APD, 250 kHz, vertical component, 1.0 kHz predetection bandwidth, April 17, 1973, 3:00 p.m., Cabin Creek, Itmann #3.

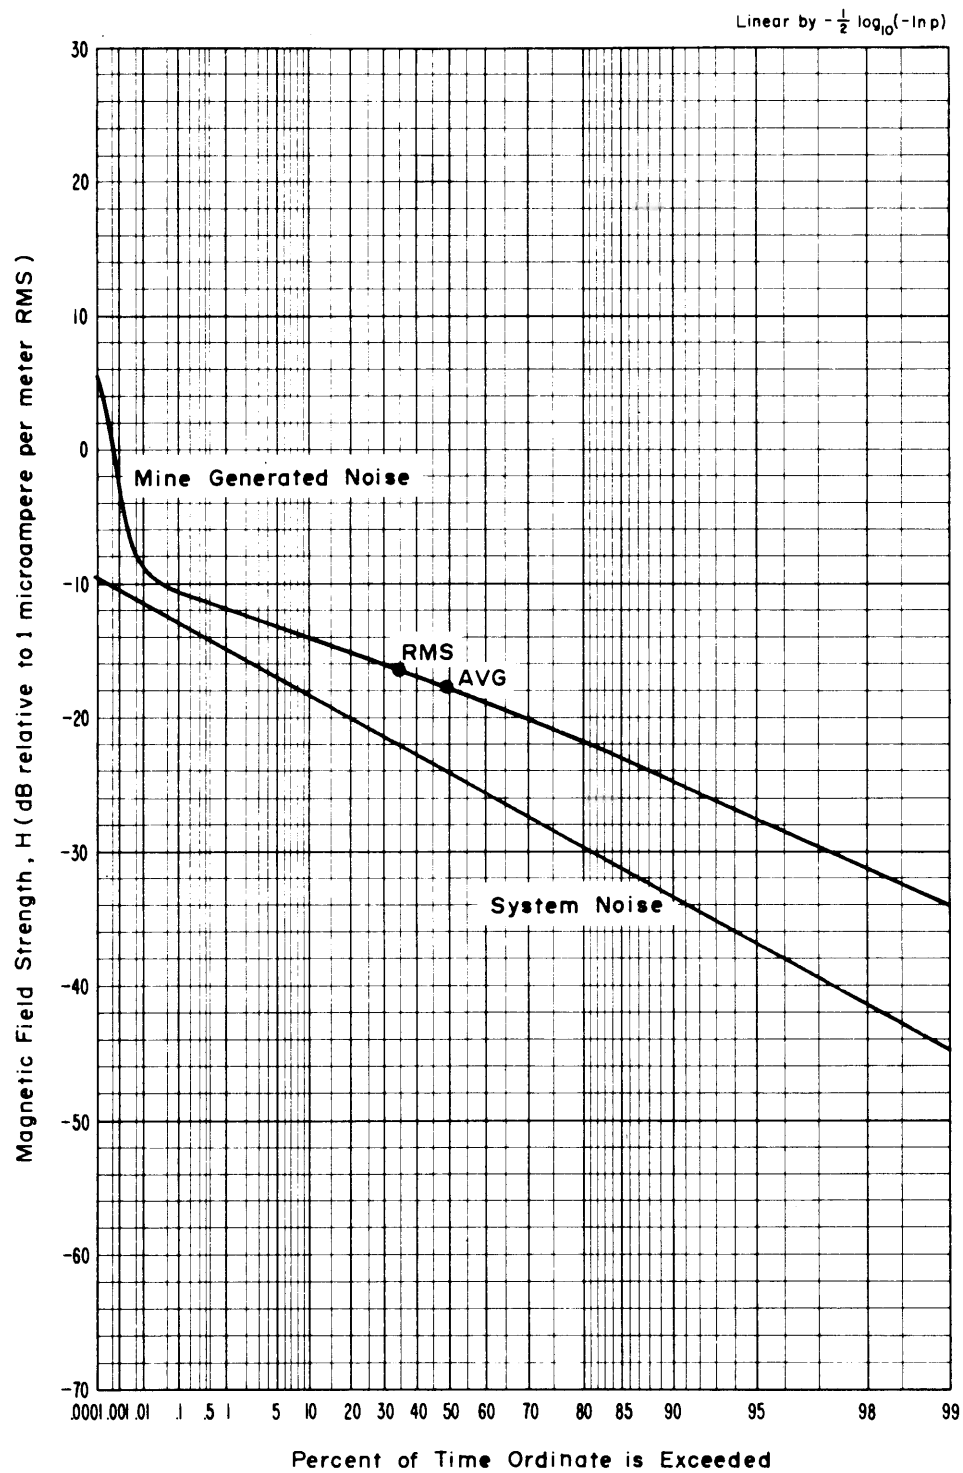
Figure 4-7 APD, 500 kHz, vertical component, 1.2 kHz predetection bandwidth, April 17, 1973, 11:40 a.m., Cabin Creek, Itmann #3.
